Contamination profile of Printed Circuit Board Assemblies in relation to soldering types and conformal coating

*Hélène Conseil, Morten S. Jellesen, Rajan Ambat
Materials and Surface Engineering, Department of Mechanical Engineering,
Technical University of Denmark, Hélène Conseil
Building 425, Kongens Lyngby, Denmark, helco@mek.dtu.dk*

Summary

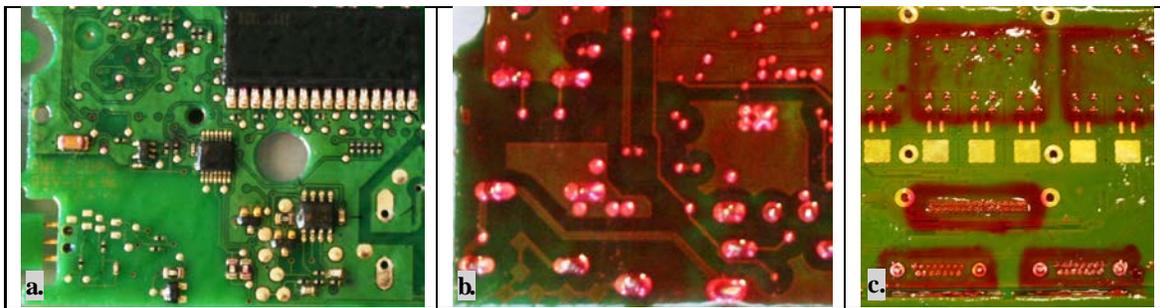
Figure 1 shows partial images of typical PCBAs tested with Residue RAT, revealing the localized contaminations on the PCBA surface as a function of involved soldering process. The patented Residues RAT gel makes use of pH change due to the presence of acid in the flux residue to reveal the colour change in an optimized manner [7].

As shown in Fig. 1a, reflow soldered PCBAs in general did not show any red coloration indicative of the absence of residues. On the other hand, PCBAs that have undergone wave and selective soldering process have shown intense colour change including clear indication of the mark of pallet used in the case of selective soldering (Fig. 1b and 1c). The red coloration in both cases indicates the presence of high levels of flux residue.

Figure 1: Residues RAT gel test on a) reflow, b) wave and c) selective wave soldered PCBs

While red coloration was seen all over the surface of the wave soldered PCBAs (Fig. 1b) (although only part of it is shown), selective soldered PCBAs showed residues only over a selected area depending on the application procedure (Fig. 1c).

The observation can be explained by the type of flux application in different soldering process.

For reflow soldering process, the use of flux in the form of paste and screen printing process limit the location of residues only to the localized areas, for example very close to or under the components.

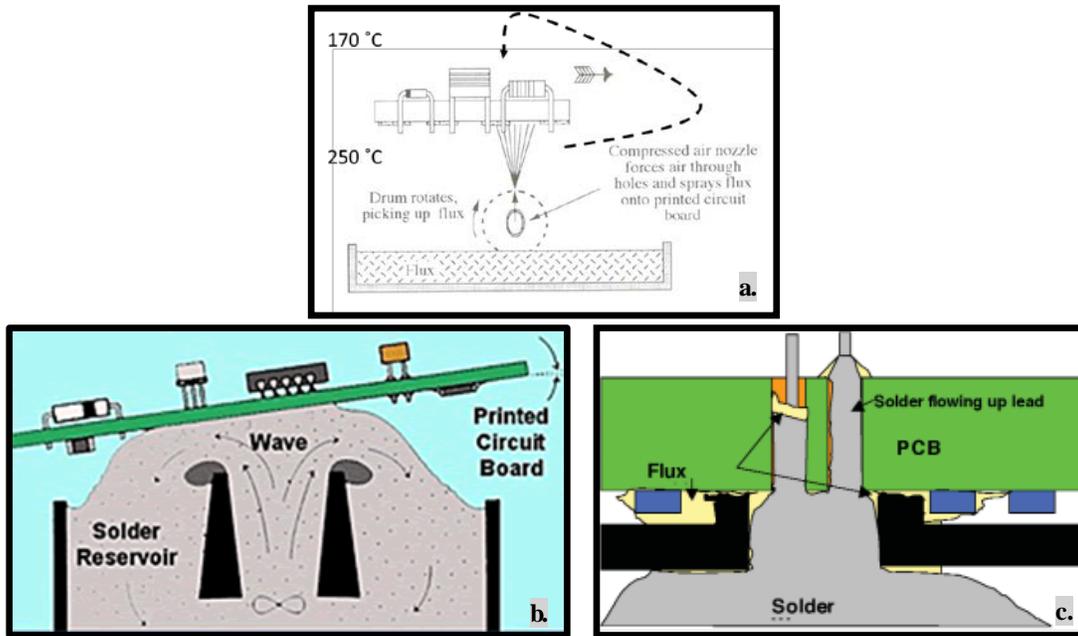
Figure 2 : Schematics of a) flux spraying at the bottom of the PCB to remove oxide on the through hole component leads and solder pad [10], b) through hole assembled PCB passing through the molten solder wave [11] and c) selective wave soldering process using a pallet [12]

In wave and selective soldering process, the flux is sprayed onto the bottom side of the PCBA, therefore resulting in wider distribution of flux on the surface. A large number of droplets can be left on the top of the PCBA, through via-holes, and the difference in the temperature of the top and bottom parts of the PCBA during soldering could introduce higher amounts of residue on the top part, where the temperature reaches only up to 170 °C (Figure 3 a and b).

In the case of selective wave soldering process, flux can be sweep under the pallet, and these trapped residues are not exposed to a sufficient temperature to be degraded (Figure 3 c).

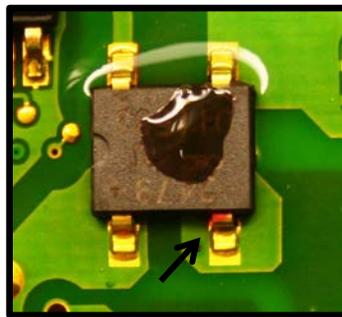
Reflow soldering flux residue can be concealed initially due to the presence of the binder and the resin part of the flux, and WOA may not be immediately released [10]. Fig. 3 shows the residue RAT gel test of the reflowed PCB after five cycles of water spraying following by slow drying under an UV light in order to open up the residues. It can be seen that after this treatment a small red spot appears under the component, showing the release of WOA. The residues were found to be concealed initially and require heavy exposure to humidity for opening up [13].

Figure 3: Residues RAT gel test on reflow soldered PCBA after severe humidity exposure

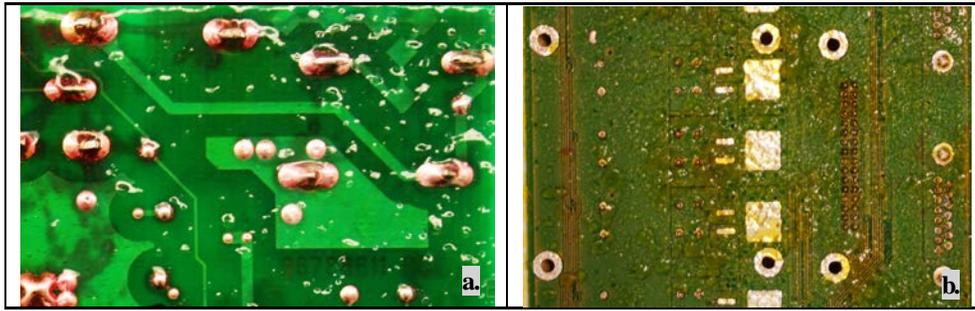
Fig. 3 shows images of Residue RAT gel test, of a typical wave and selective soldered PCBAs similar to the ones shown above in Figures 1b and 1c, however, after a simple cleaning process, by rinsing with a solution of Isopropyl alcohol and Millipore water at 3:1 ratio and scrubbing with a soft tissue, and rinsed again with the same solution to avoid any additional contaminations from the tissue. It is clearly showed that the acid residues are decreased, however little residues were found at some localized regions.

Figure 4: Residues RAT gel test on cleaned a) wave soldered PCBAs and b) selective wave soldered PCBAs

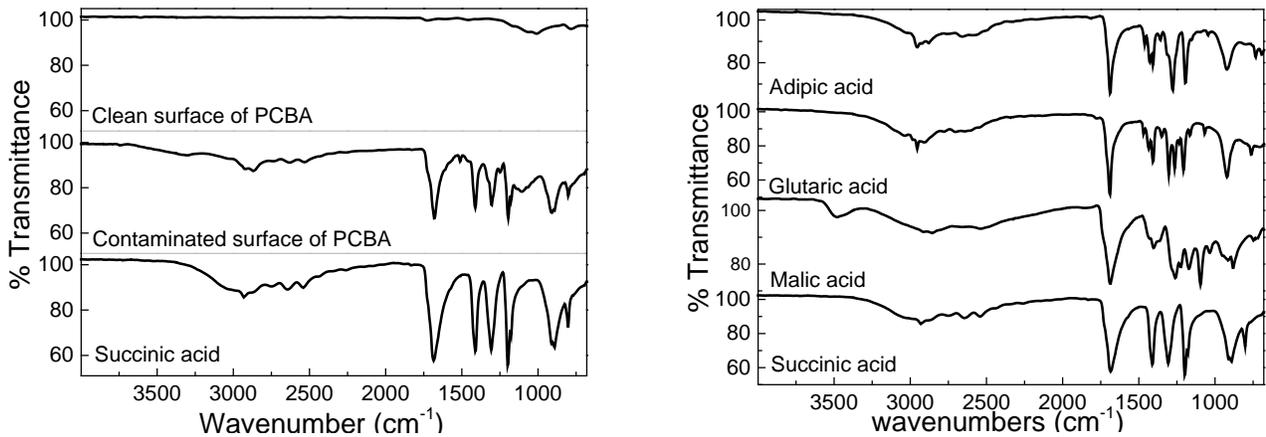
In order to confirm that the contamination revealed by the residue RAT gel corresponds to flux residue, FTIR analysis were performed directly at the contaminated area on the PCBA surface, using a microscopic IR spectrophotometer with ATR. Typical spectra shown in Fig. 5a, clearly show that the chemistry of the contaminated area of the PCBA of the Fig. 3. a. corresponds to weak organic acid (succinic acid in this case), the active part of the flux systems. Similar evaluations of PCBAs showed such acids (Fig.5b).

Figure 5: FTIR spectra on the surface a) of wave soldered PCBA and b) of typical contamination found on the surfaces of WOAs

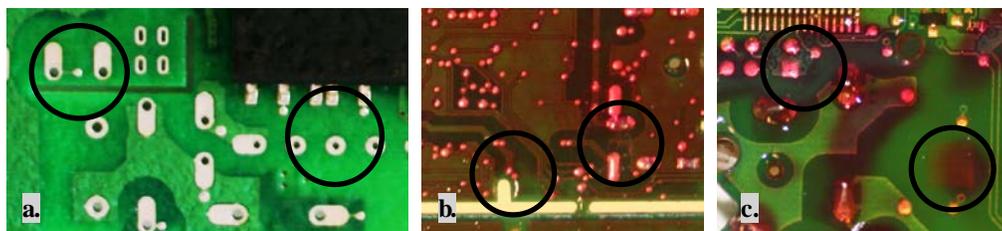
Figure 6: Selected areas for optical microscope pictures, of a) reflow b) wave and c) selective wave soldered and coated PCBs

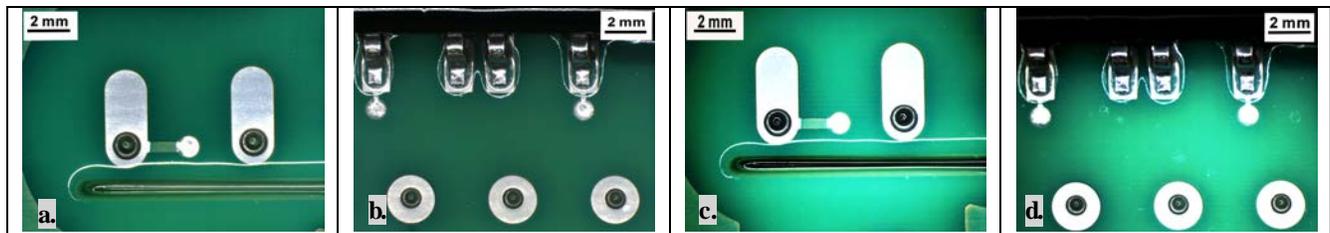
Figure 7: Optical microscope pictures of reflow soldered and coated PCB, a) b) before and c) d) after 3 weeks exposure to saturated humid

Results show that the conformal coating on reflow soldered PCBA remained unaffected during the three weeks of exposure (Fig. 7) (no blisters were found on the surface). But on wave and selective soldered PCBAs (Fig. 8 and 9), the conformal coating showed signs of deterioration and the majority of the blisters appeared at the same areas where a high level of contaminations were found by the Residue Rat testing. It clearly indicated that the excessive levels of contamination could introduce problems for conformal coating under humid conditions. This is expected, as the ionic contaminants under the coating will influence the water transport through the coating due to osmotic pressure, while the adhesion of the coating is affected by the contamination at the interface [14-16].

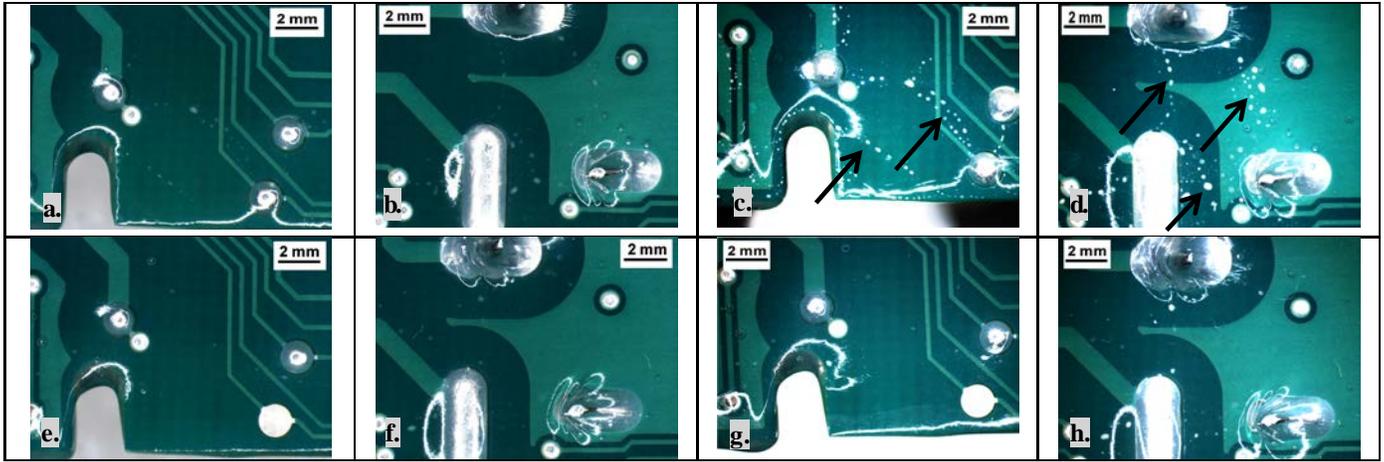
Figure 8: Optical microscope pictures of as received wave soldered and coated PCB, a) b) before and c) d) after 3 weeks exposure to saturated humid, and cleaned wave soldered and coated PCB, e) f) before and g) h) after 3 weeks exposure to saturated humid

However, in both cases, cleaning of the PCBA has enhanced the performance of the conformal coating, indicating a direct relation between the contamination and the blister formation.

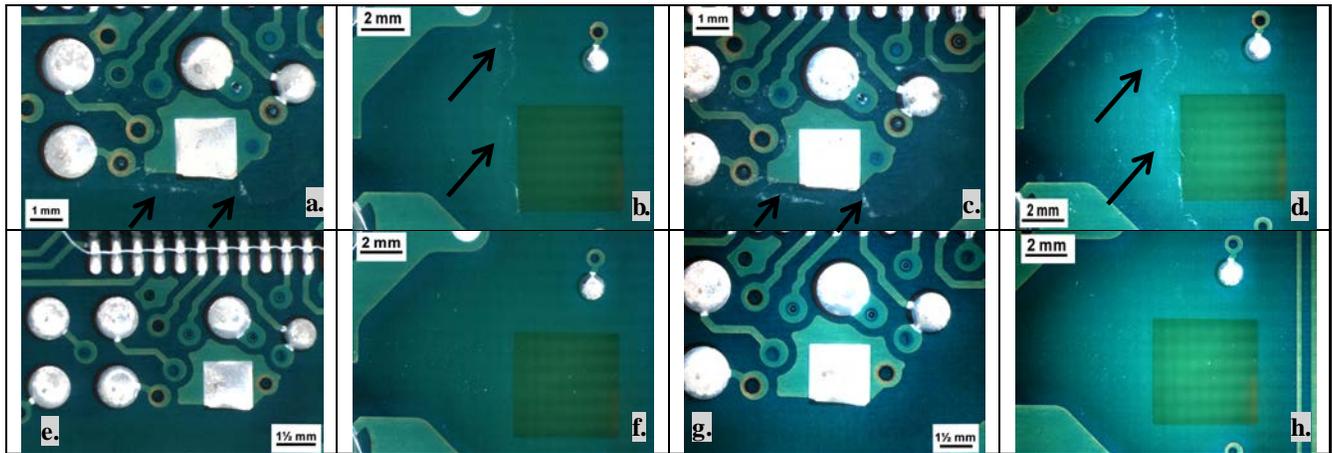
Figure 9: Optical microscope pictures of as received selective wave soldered and coated PCB a) b) before and c) d) after 3 weeks exposure to saturated humid, and cleaned selective wave soldered and coated PCB, e) f) before and g) h) after 3 weeks exposure to saturated humid
